PEM Fuel Cells: Materials Ageing and Degradation

R.A. Silva, T.I. Paiva, C.M. Rangel

LNEG - Laboratório Nacional de Energia e Geologia, Fuel Cells and Hydrogen Unit,
Paço do Lumiar, 22 1649-038 Lisboa Portugal
raquel.silva@lneg.pt; teresa.paiva@lneg.pt; carmen.rangel@lneg.pt

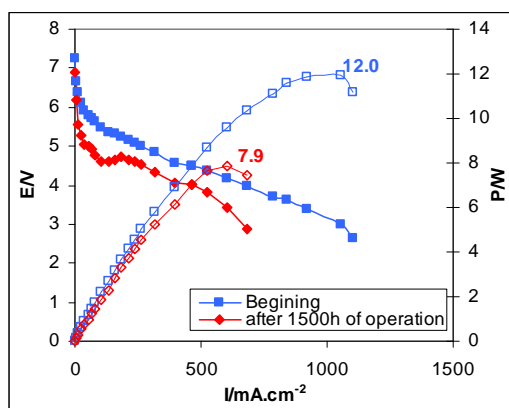
Figure 1 shows the polarization curves of the fuel cell before and after 1500h of operation. The polarization curve obtained after cell activation exhibited maximum current densities over 1000 mAcm⁻². Load duty cycles included open circuit, constant current and full polarization curves in a step by step fashion. Data were obtained at 500 mbar H₂ relative pressure, room temperature with the air flow rate of 7.56 L.min⁻¹ in a range of currents which varied from nearly zero (near the open circuit potential) to 3 A. The maximum power of the cell was found to be reduced in 34 % after operating for 1500h.

The degradation in performance after 1500h of operation is clearly evident in the activation, ohmic and mass transfer regions.

Fig. 1 Polarization curves for the 3.8 cm² stack operated at 0.4L.min⁻¹ hydrogen flow rate under constant air flow rate of 7.56 L.min⁻¹ at 500 mbar, at room temperature, after activation and after 1500h operation.

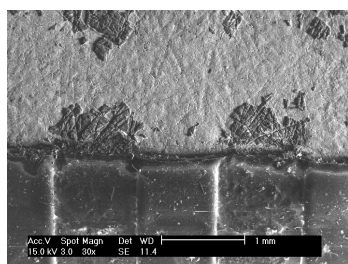
During the dismantling process, part of the GDL was peeled away and part of the GDL remained stuck on the catalyst layer. Figure 3 shows residues of GDL as light areas on the cathodic catalyst layer of C5. The residue actually shows that the compression force used in the assembly of the stack caused the bipolar plate to press the GDL into the catalyst layer. This compression will have an impact on the catalyst layer and GDL porosity underneath the ribs of the bipolar plate. It was observed, in all the cells, a GDL debris in both the anode and the cathode. In the case of C8, the anodic catalytic layer was totally covered with GDL; removal was accomplished after immersion in hot distilled water.

Fig.3 GDL debris on the cathodic catalyst layer surface of C5.

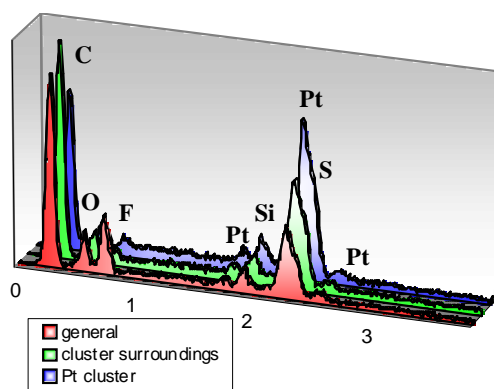
EDS analysis was performed on clustered areas, which were shown to be platinum rich. The results obtained on the Pt cluster and its surroundings are presented in figure 5 exhibiting agglomerates of catalyst. A spectra of an area where clusters were not observed is included for comparison.

Fig. 5 EDS of a Pt cluster and surroundings surfaces.

The high concentration of platinum could result from catalyst detaching from the carbon supporting surface. The catalyst particles agglomerate to form a catalyst cluster. Pt clusters were also observed on the unused sample. The catalyst agglomeration leads to a gradual decrease in the electrochemically active surface area, increasing by this way the activation loss.

The presence Si has been identify in the EDS spectra in figure 5. The use of silicone piping and the sealing gasket are believed to have introduced silicon contamination in the MEA.

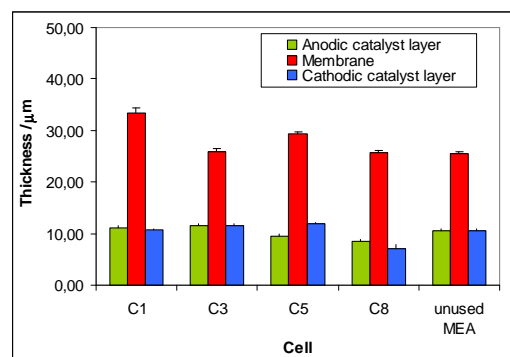
MEA **thickness variations** may occur from the manufacture process or from the assembling pressure. Figure 6 shows from three MEA components (membrane, anodic and cathodic catalyst layer) a thickness decrease comparatively with the unused MEA. The decrease is more evident for the cell that suffered the highest degree of degradation and for which the assembling pressure have more drastic consequences (C8).

The thickness variations have an effect on the resistance through the MEAs and on the susceptibility to the degradation. The thinner areas of the catalyst layer will have a lower electronic resistance, while the thinner electrolyte areas lower ionic resistance.

Fig. 6 Thickness variation of MEA components for cells C1, C5 and C8, relatively to the unused MEA.

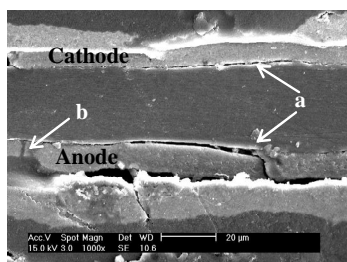
A very common feature among all of the analyzed MEAs is the **cracking** of the catalyst layer. As shown in figure 7 it involves the cracking of the catalyst layer, but leaves the Nafion™ membrane mechanically undamaged. Thus, the fuel cell can still operate, but performance and durability may be reduced.

Fig. 7 Cross section SEM view of the MEA for C8 cell showing delamination (a) and cracking (b).

The cracks will increase the total resistance of the catalyst layer and if it leaves parts of the membrane exposed, the contact resistance between the catalyst layer and the membrane will also increased. On the other hand, the cracks will provide areas where the water could accumulate preventing reactant gases to reach the catalytic sites and consequently, reduces the reaction rate.

Another important consequence is the catalyst erosion due to the exposure of the catalyst surfaces to agents such a water and gas flux.

Delamination describes a MEA failure feature whereby the catalyst layer has been separated from the polymer membrane electrolyte as shown in figure 7.

This type of defect may result from MEA manufacturing procedure but can also be induced by the degradation of the catalytic layer. It forces the current to flow away from delaminated zones, through neighboring regions in which heat is locally produced. As these neighboring zones are also prone to water accumulation, they may degrade faster than other parts of the catalytic layers.
